NASA Contractor Report 159056

Repair Techniques for Graphite/Epoxy Structures for Commercial Transport Applications

**R.H. Stone
Lockheed-California Company
Burbank, California**

**Contract NAS 1-15269
January 1983**

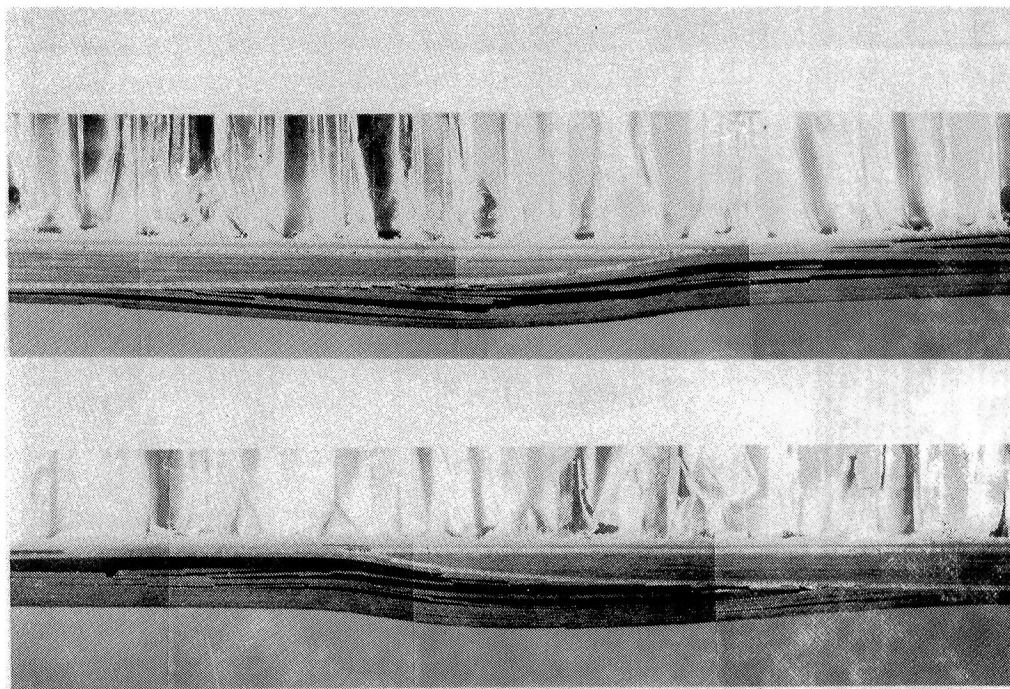
Figure 30. - Type I specimen after test showing poorly machined scarf taper.

One flush, aerodynamic cure-in-place graphite repair was evaluated with the 16 ply laminate, (Type I) and joint efficiency was much lower than the other flush repairs and was lower in compression than the external patch repairs. A careful micrographic examination of the failure showed that the taper had not been machined properly. (Figure 30). The taper angle was too steep in some areas resulting in a high tensile load component which caused premature failure.

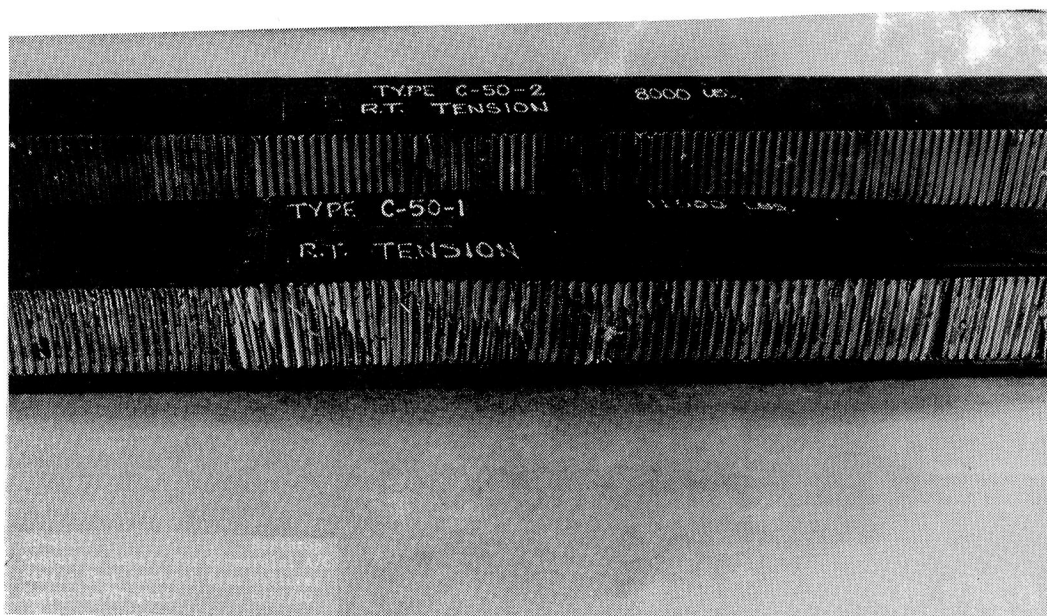
Figure 31. - Type C-50 specimens after testing.

C-50-9 Failure occurred as through the thickness fiber splitting (as C-16) at the location of core splice. Scattered delamination close to top and bottom of composite in various locations along laminate.

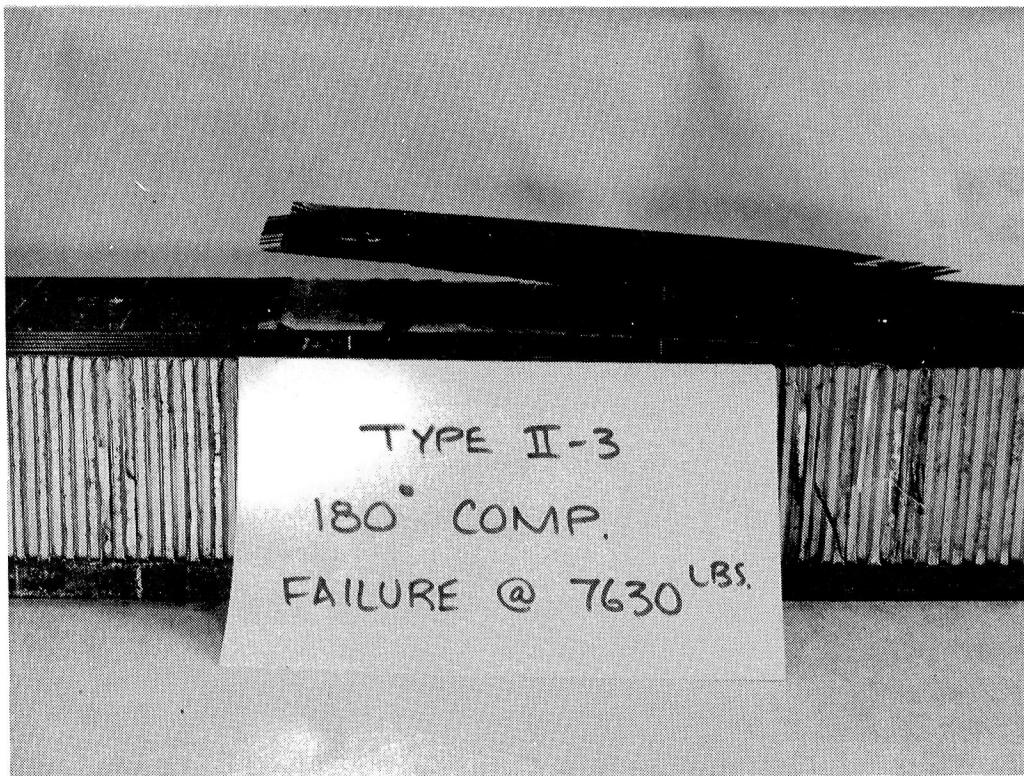
Figure 32. - Type II specimens after testing.

The failure modes for the flush repairs are given in Tables VI and VII and are described more fully in Appendix B. As expected the cure-in-place repairs with vacuum cured patches failed primarily by delaminations in the patch, whereas the pre-cured bonded repairs failed principally in the patch-parent bond line. It is significant, that despite the differences in failure modes, the two directly comparable full thickness repairs with cure-in-place and pre-cured patches (Types II and III) had comparable joint efficiencies. Figures 31 through 35 show typical flush repair specimens after testing.

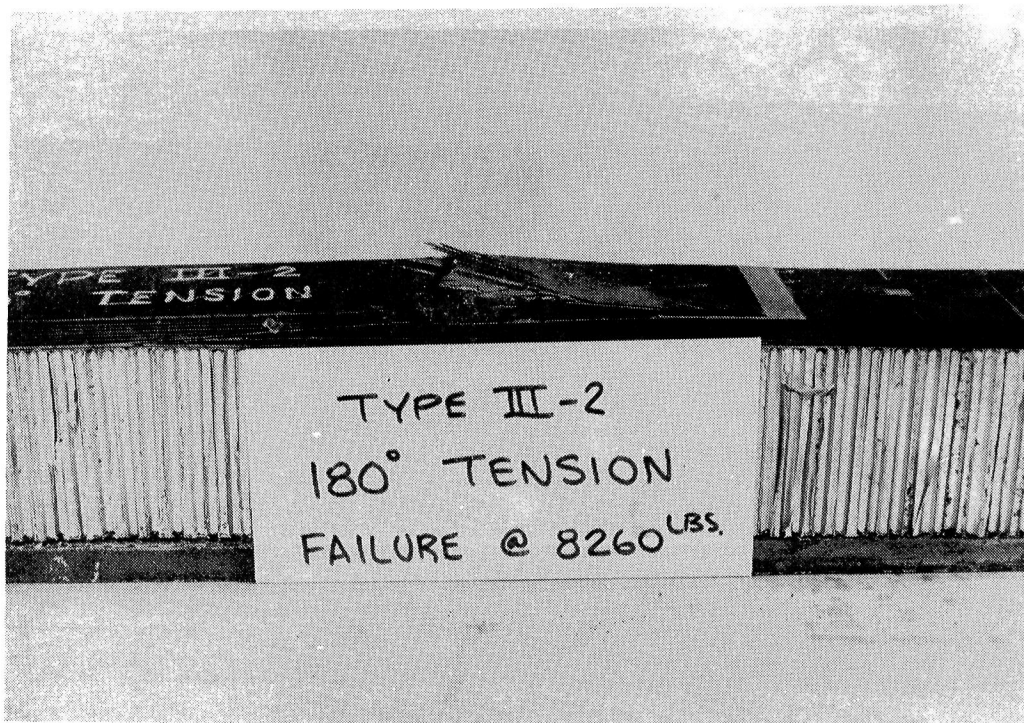
Figure 33. - Type III specimens after testing.

III-5 Adhesive bondline failure resulting in cover ply fracture at top of scarf.

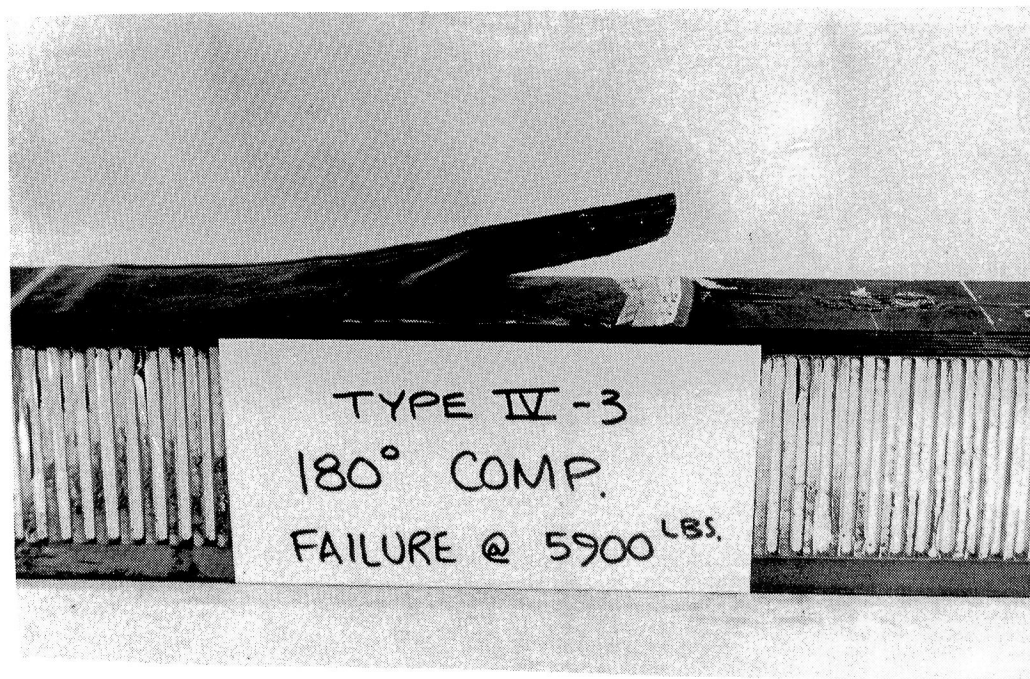
Figure 34. - Type IV specimens after testing.

IV-5 Parent interlaminar tensile failure at maximum depth of part-through repair. Failure of one patch scarfed surface.

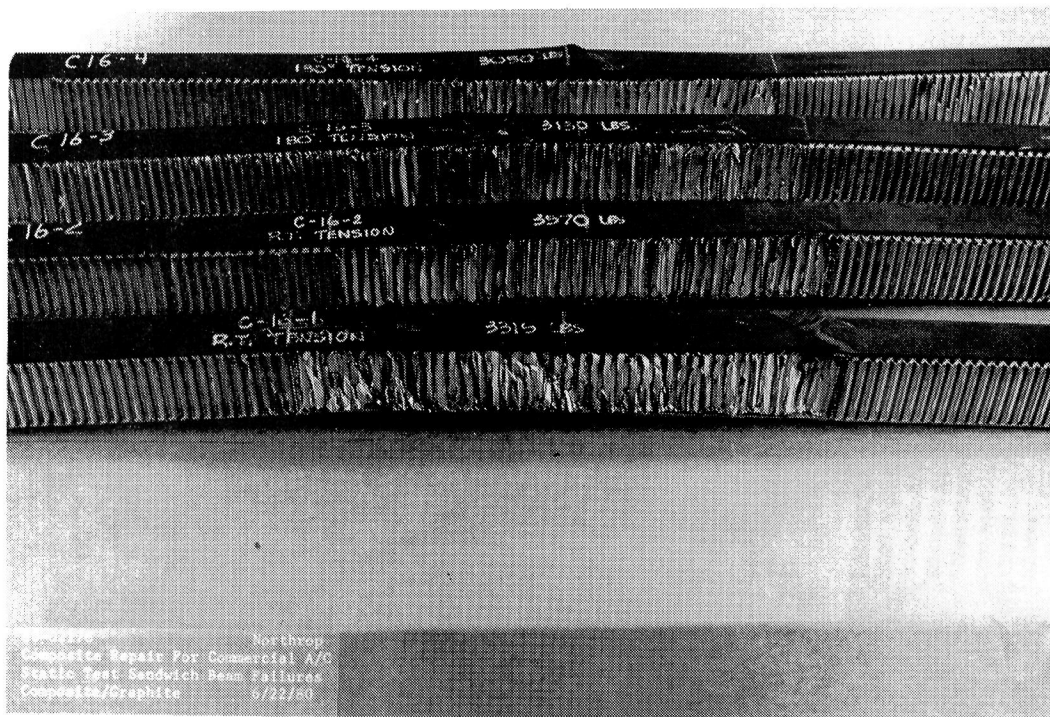
Figure 36. - Types C-16 specimens after testing.

C-16-9 In both specimens a through the thickness fiber splitting type
-10 failure resulting in ply separation, composite/core and titanium/core separation. Failure progresses through gage section honeycomb to titanium face sheet disbond.

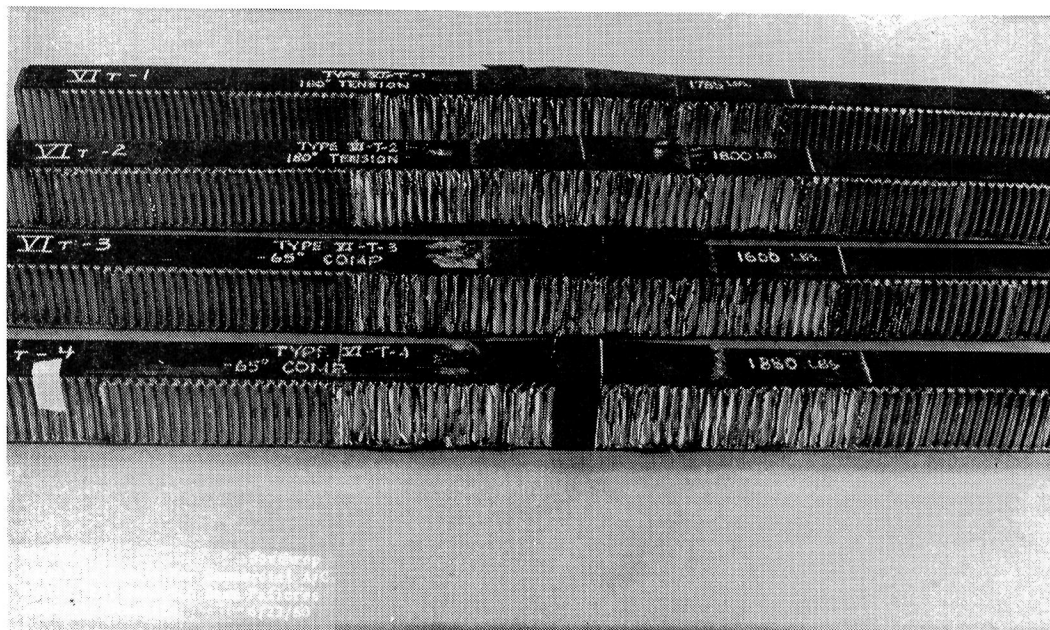
Figure 37. - Type VI-T specimens after testing.

VI-T-9 Failure progressed through first patch ply to plug fracture. Very similar to static tension failures. Both sides of external patch failed.

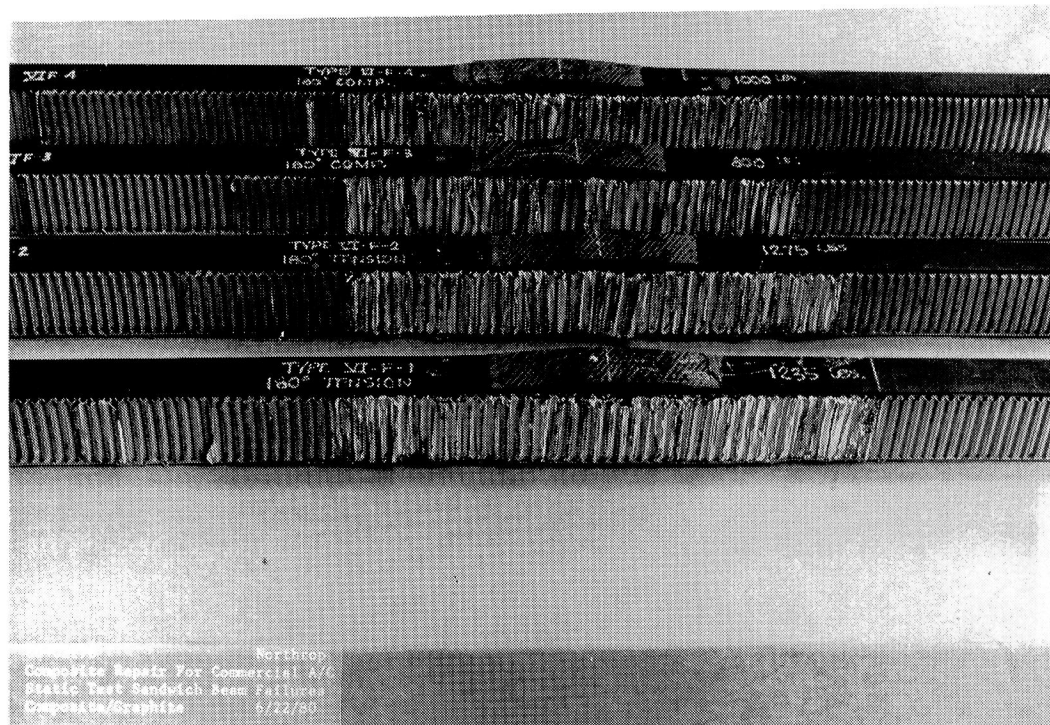
Figure 38. - Type VI-F specimens after testing.

VI-F-5 Failure progressed through top ply of parent to plug fracture. Only one side of external patch failed.

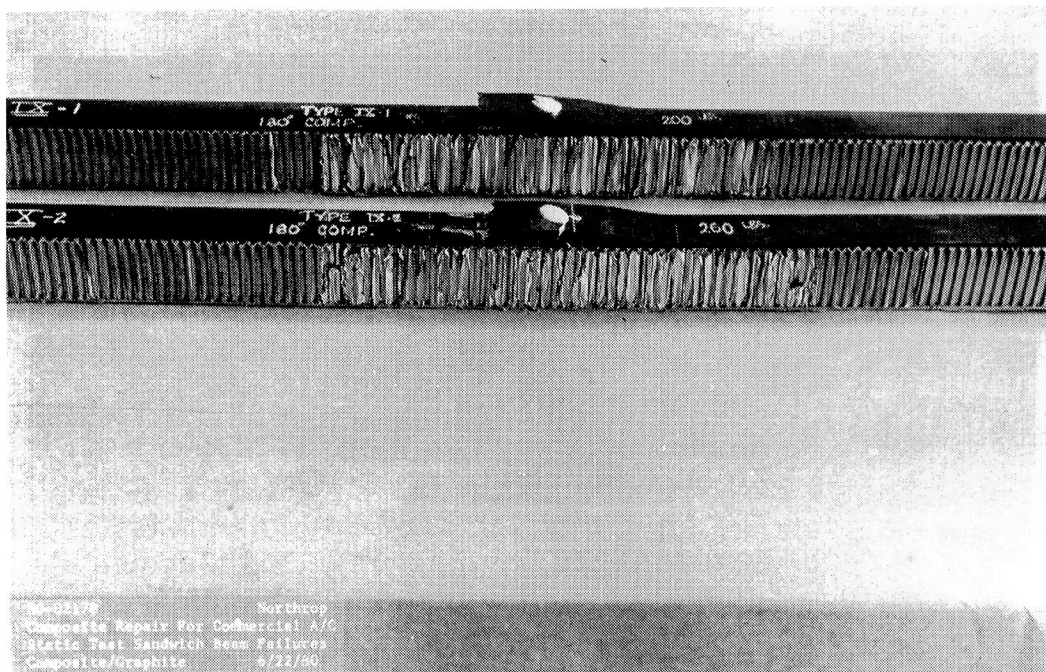
Figure 41. - Type IX specimens after testing.

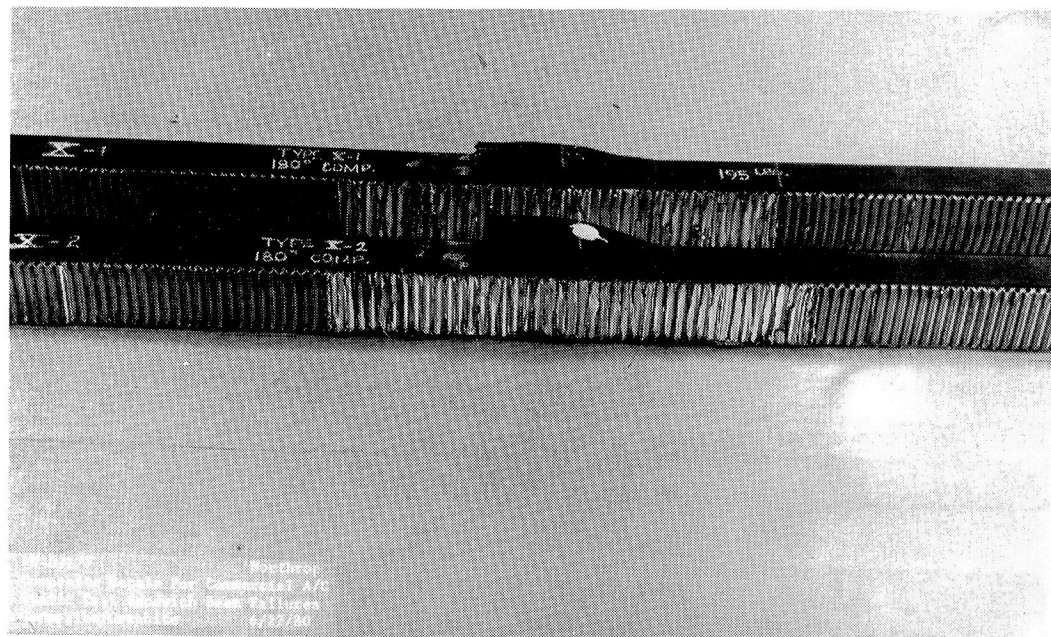
Figure 42. - Type X specimens after testing.

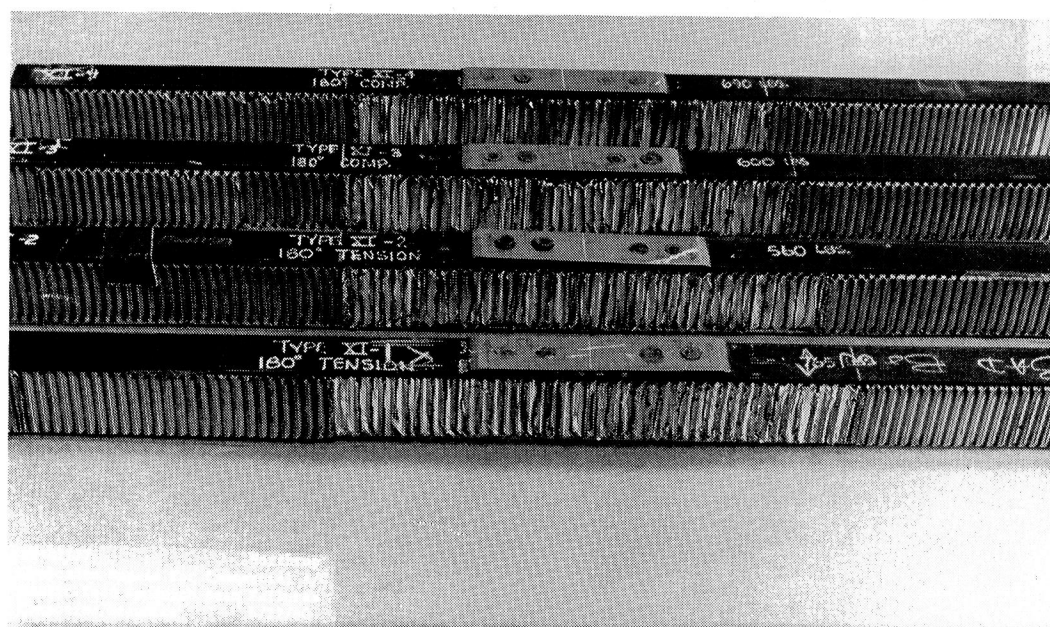
Figure 43. - Type XI specimens after testing.

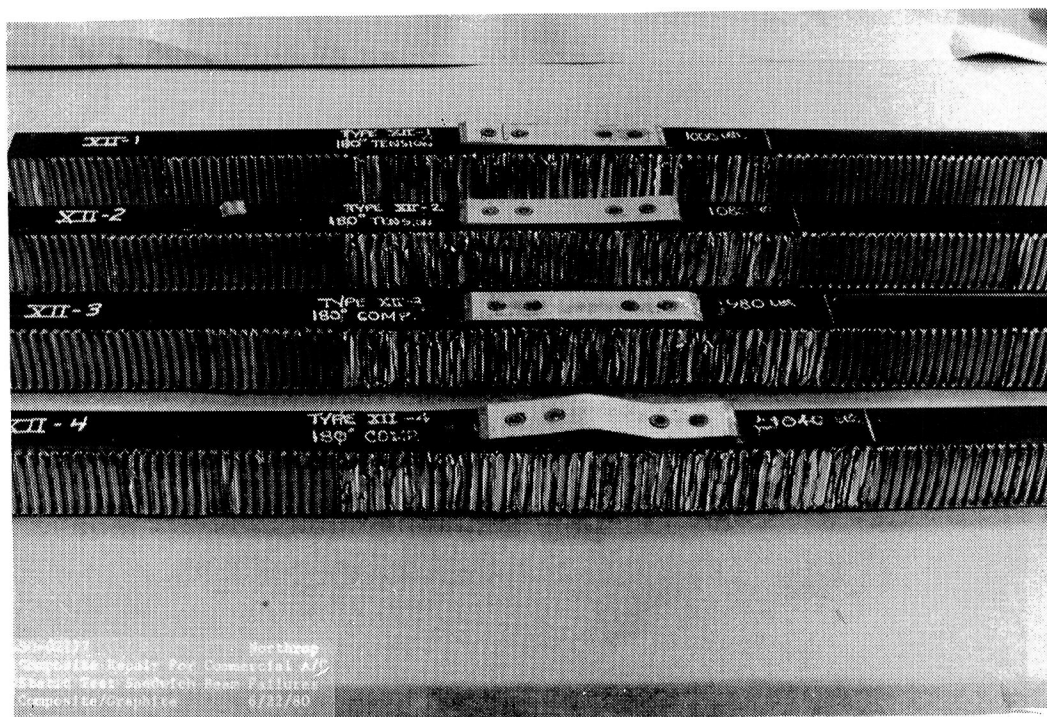
Figure 44. - Type XII specimen after testing.

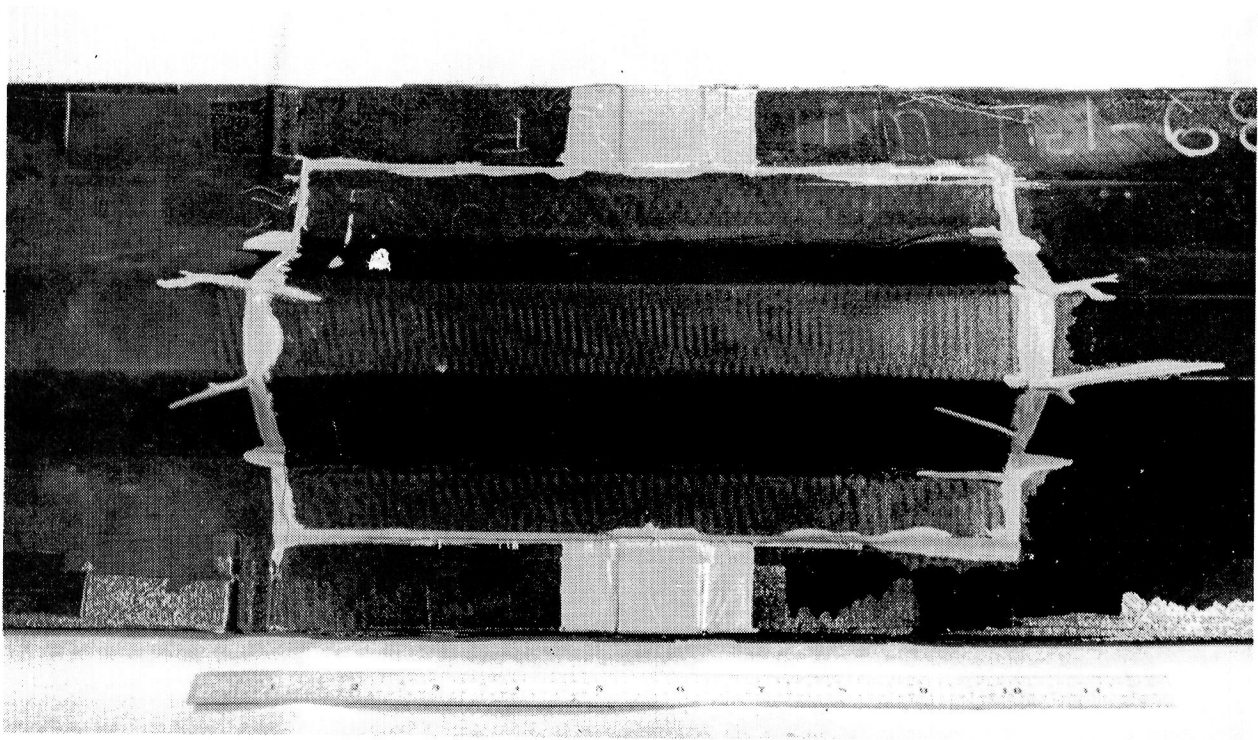
Figures 59 and 60 are photographs of the finished hat-section and external skin patch repairs.

Figure 59. - Completed hat-section repair for the vertical fin cover panel specimen (Type I).

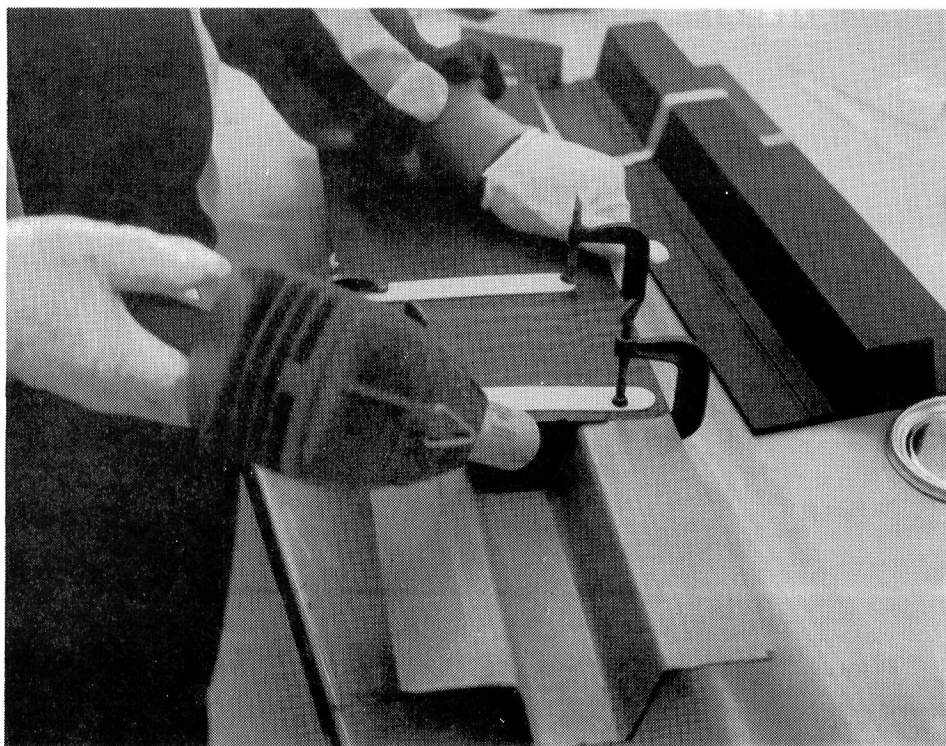
The precured hat-section patch was lined with one layer of M-329 film adhesive, as shown in Figure 62, extending 0.51 cm (0.2 in.) beyond the ends of precured hat. The parent halves, skin side up, were then fitted into the hat patch cavity and clamped in place using a hot air gun to aid assembly (Figure 63). The gap between the scarved ends of the parent halves was 4.06 cm (1.6 in.) A bead of ECN 1299 room-temperature curing adhesive paste thickened with Cab-O-Sil powder was placed around the ends of the parent hat sections and cured overnight to provide a seal at the bondline during cure (Figure 64). The rubber plug was inserted (Figure 65) and the skin patch replacement plies laid up matching the parent skin orientation (Figure 66). The replacement plies, along with film adhesive and cover plies, as shown in Figure 54, were assembled, clamped together, and vacuum cured as described in Section 2.4.1 for the Type I repair.

Figure 63. - Fitting of parent segments to hat splice plate.

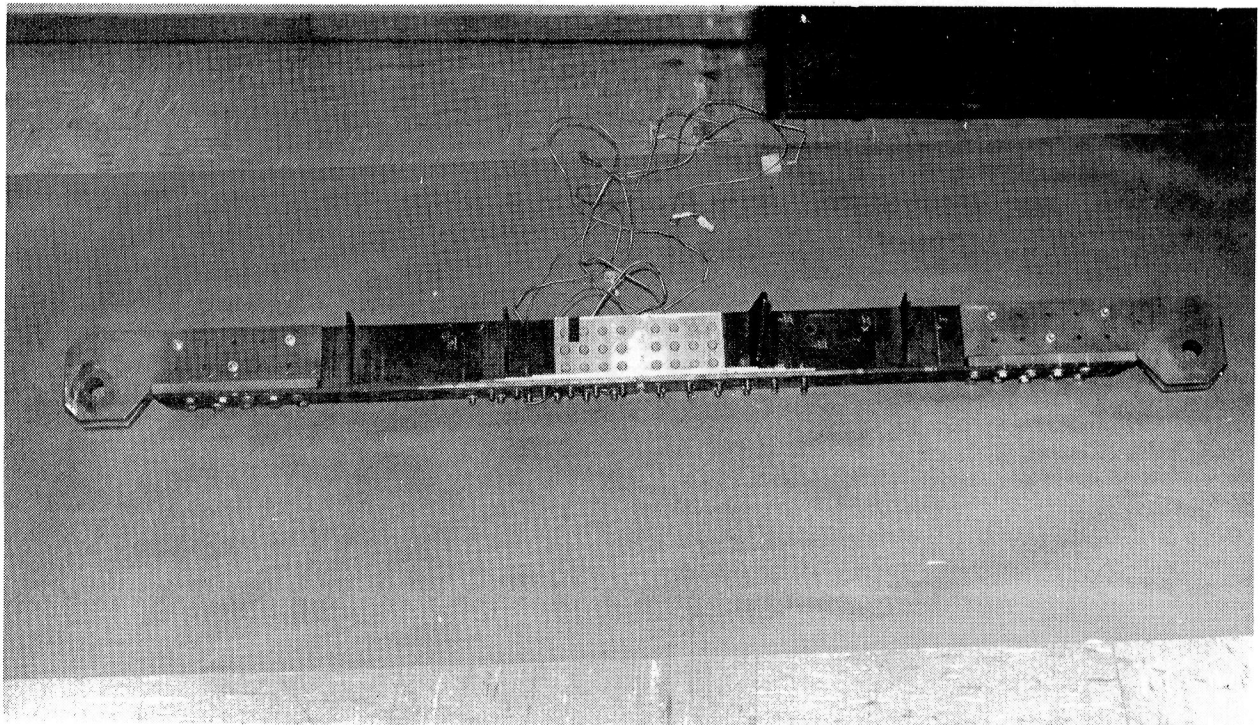
The design philosophy of the repair was to use the existing fastener holes in the cap and to use a fastener spacing of 4D in the web section. The existing holes in the cap were not equally spaced, so the cap splice plates on either side of the web were made different lengths in order to provide the required number of fasteners for shear transfer. The repair configuration is shown in Figure 56. The aluminum plates were cut to size, clamped in place on the spar segment, and match drilled using hand-held equipment. The repair was assembled using MIL-8802-B2 polysulfide faying surface sealant for corrosion protection. Forty-eight fasteners were installed as detailed in Figure 56. Because of the nature of the repair, no postrepair moisture reconditioning was performed on the specimen. Figure 68 shows the completed repair.

Figure 68. - Completed vertical fin spar segment repair (Type III).
